Repair of the anti-corrosion protection of the pressure pipeline at Naturno (Italy) hydropower station

A. Zwanzinger, E. Rainer, B. Kommenda

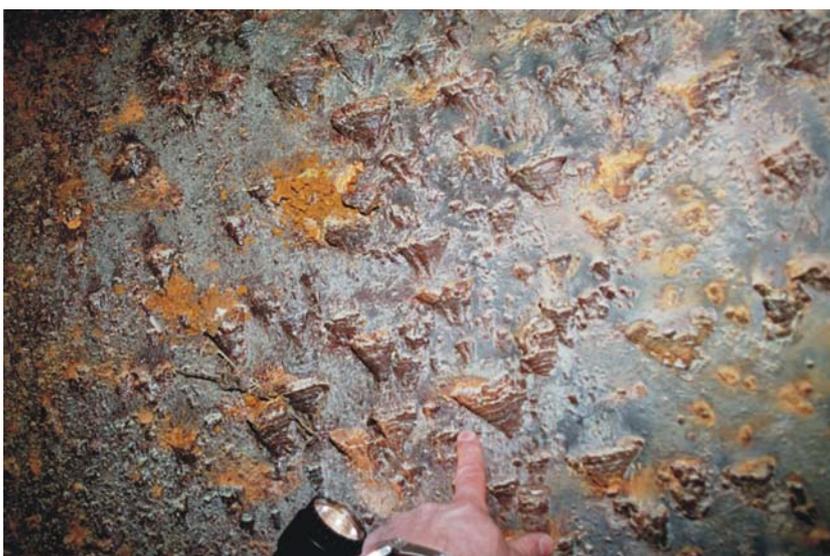
Large surfaces of the old coating, on a tar basis, were destroyed by rust pustules. These pustules were several cm wide and high. In the bottom area, almost no smooth areas without pitting corrosion or perforations remained to be found.

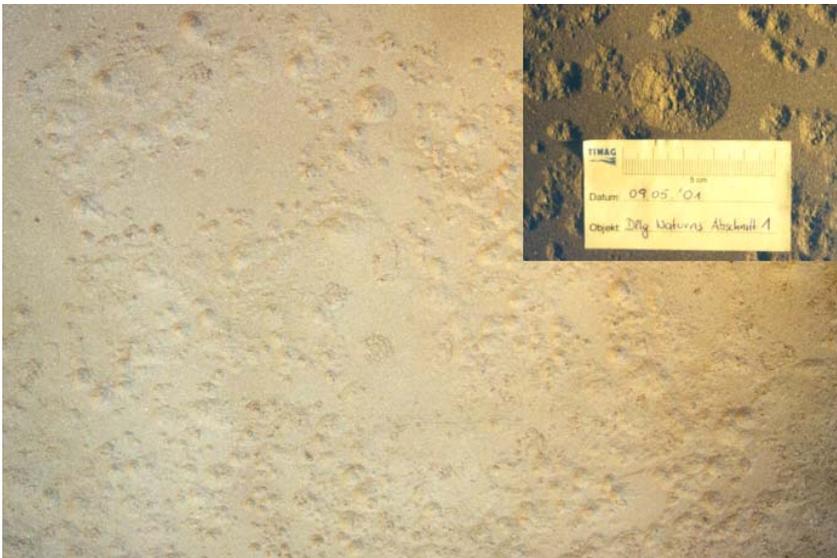
The picture on the left shows the enormous corrosion damage, visible after removing the rust by blast cleaning.

In the sloping area too, the perforations and pitting corrosion were deep, especially on the bottom, where the old coating was probably already damaged in an early stage by abrasion.

After approval of the sand blasting works by the quality assurance personnel of TIWAG and a sample survey test of the welding joints, the partial section concerned was released for coating. In the description of the working method, due to the corrosion damage (especially on the bottom) and to the load that it is expected to be subjected to, it was prescribed that Humidur[®] would be applied in two layers, of two different colours (the first layer squirrel grey, the second and final layer pure white) with a total dry layer thickness of at least 800 µm on the bottom (circular segment between 4 and 8 o'clock) and at least 600 µm on the remaining part. The application was carried out crosswise, by means of Airless spraying equipment.

After a drying time of 48 hours, it was possible to drive over the first coating layer (applied directly on the steel – no primer) with the trolley, and to check it visually for pores. Open pores, severe pitting corrosion and perforations were repaired with Hu-

midur[®] P, using a spatula, after which the second and final layer of Humidur[®] was applied.

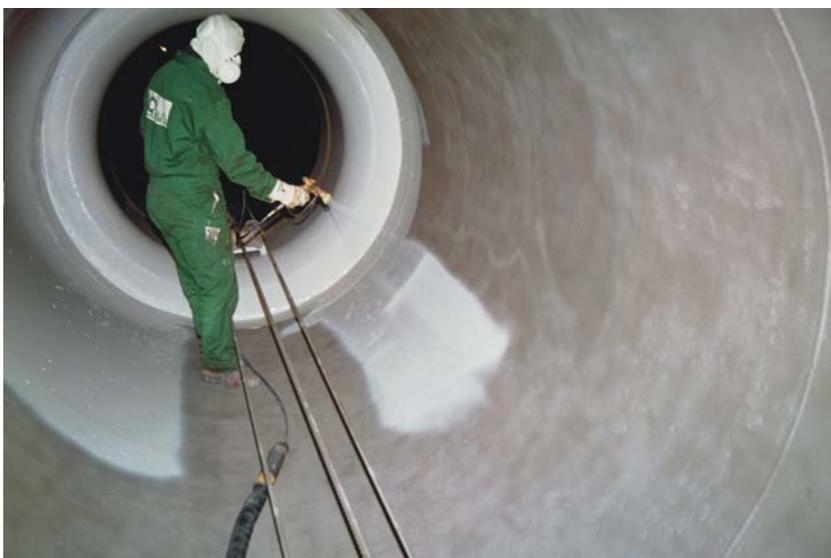
The first partial section in section 2 was a flat part of about 100 m up to the first bend (about 700 m²). The picture shows the application of the first Humidur[®] layer on the cleaned steel surface.

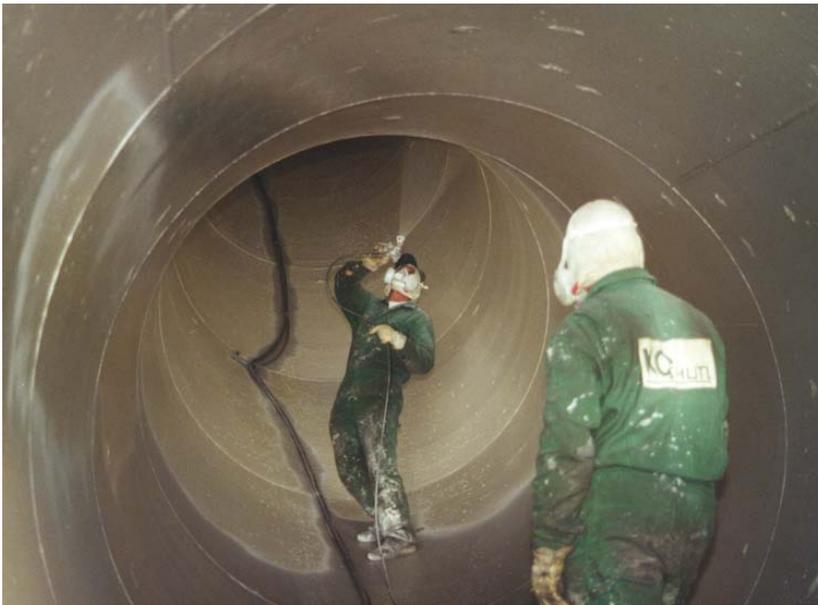
The two butterfly valves that flange the bottom side of the S-shaped armoured supply tunnel, and the diversion pipeline were disassembled. The picture shows the application of the second layer of Humidur[®] on the S-shaped supply water tunnel. The diameter is 2,4 m, the length up to the sliding room about 65 m. Since the slope was not steep here and not too long, it was not necessary to use a trolley.

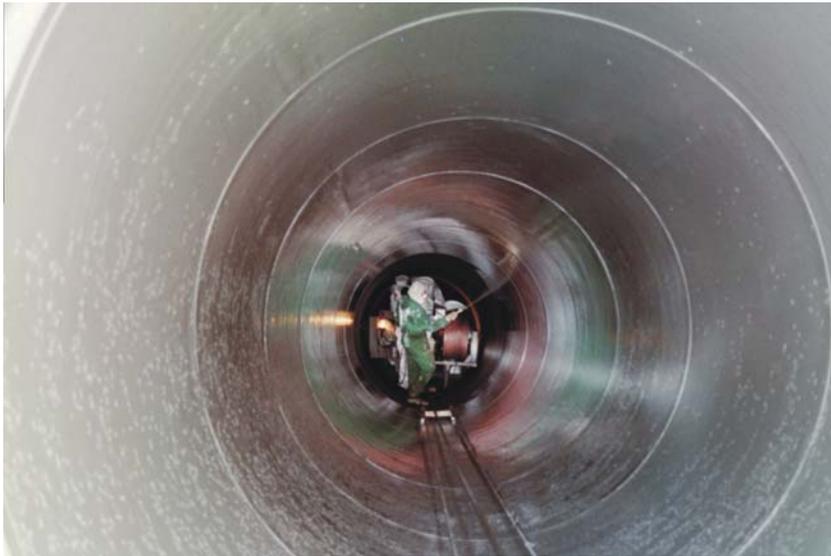
After the sandblasting had been checked, the working trolley was loaded with Humidur[®] and the first layer of Humidur[®] was sprayed from the top to the bottom. The Airless spraying equipment was installed on the other end of the trolley, on which the two components of Humidur[®] were mixed too. Since the ambient temperature temporarily

fell below 10° C (especially at night and depending on the temperature outside) only 100 m away from the spot where air was blown in and the Humidur[®] product cooled down too much, it was necessary to use electrical equipment to heat up the Humidur[®] product before mixing. Remark: the ideal temperature for the material before mixing is between 20 and 25° C. Additionally, the 10 m long spraying hose too was electrically heated up to about 35° C.

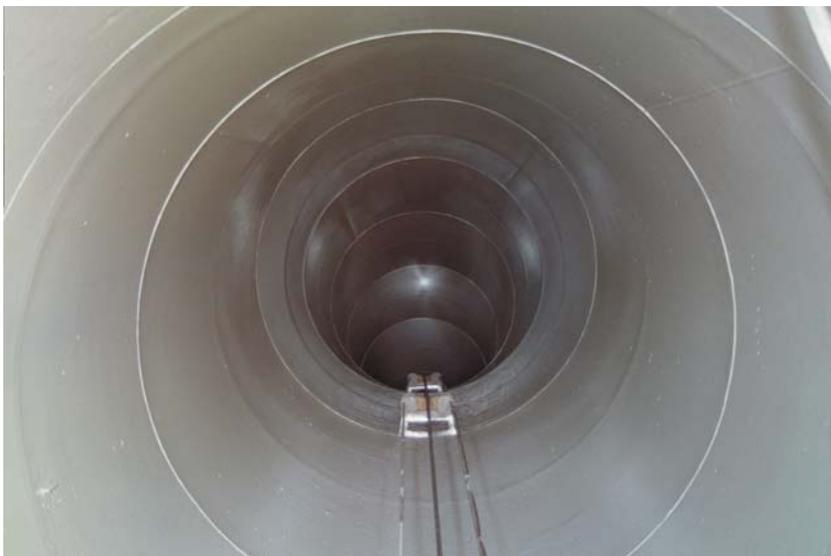
The picture on the left shows the finished first applied layer on the area of a positive bend in the pipeline and the cables and the deflection pulley of the trolley installation. Since the spraying was done from the top to the bottom and the working trolley stood under the newly sprayed surface, the sandblasting works

could be continued during curing time. After 48 hours the trolley could drive over the coating and the second layer of Humidur[®], this time white-coloured, could be sprayed.

After sufficient curing time, the whole surface was checked for pores with high voltage detectors and the layer thickness was measured. When, during the final checking, pores were found, they were coated with Humidur[®] (variant for application by brush). Remark: also on the almost cured Humidur[®] surface, another layer can be applied without blasting or roughening, at any time. This property is an important advantage for applications of more difficult projects. For the treatment of separate sec-

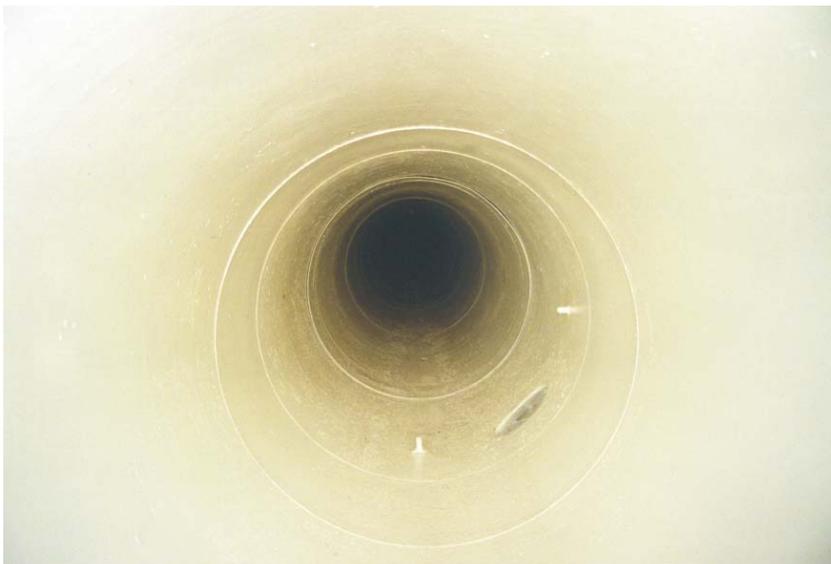
The picture on the left shows the finished coated pipeline after the trolley installation has been dis-assembled. On the right side there is an inspection manhole, (38 x 28 cm, oval), which was closed during the reparation works, by means of a wooden form.

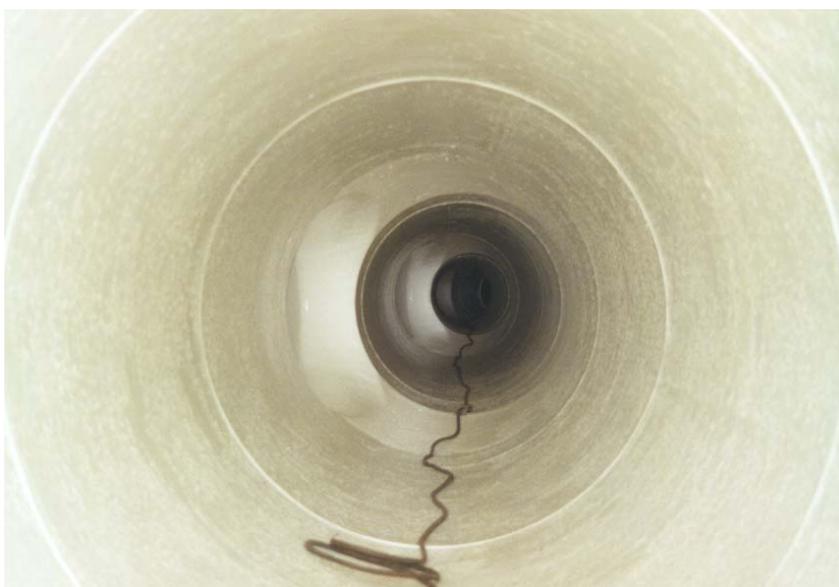
The picture on the left shows the distribution pipeline, after the coating was finished, getting more narrow from turbine to turbine. At the end of the distribution pipeline, the exhaust pipes for the acclimatisation were installed.
