Repair of the anti-corrosion protection of the pressure pipeline at Naturno (Italy) hydropower station

A. Zwanzinger, E. Rainer, B. Kommenda

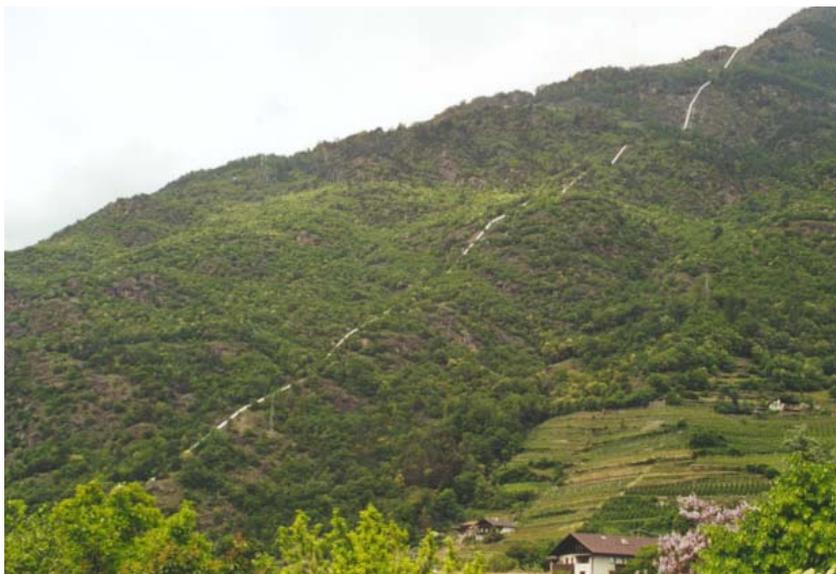
The picture on the left shows the pipeline, enveloped in a nearly 5 cm thick insulation, covered on the outside with aluminium foil and canvas. The insulation was applied in the late autumn of 2000, so before the pipe was emptied.

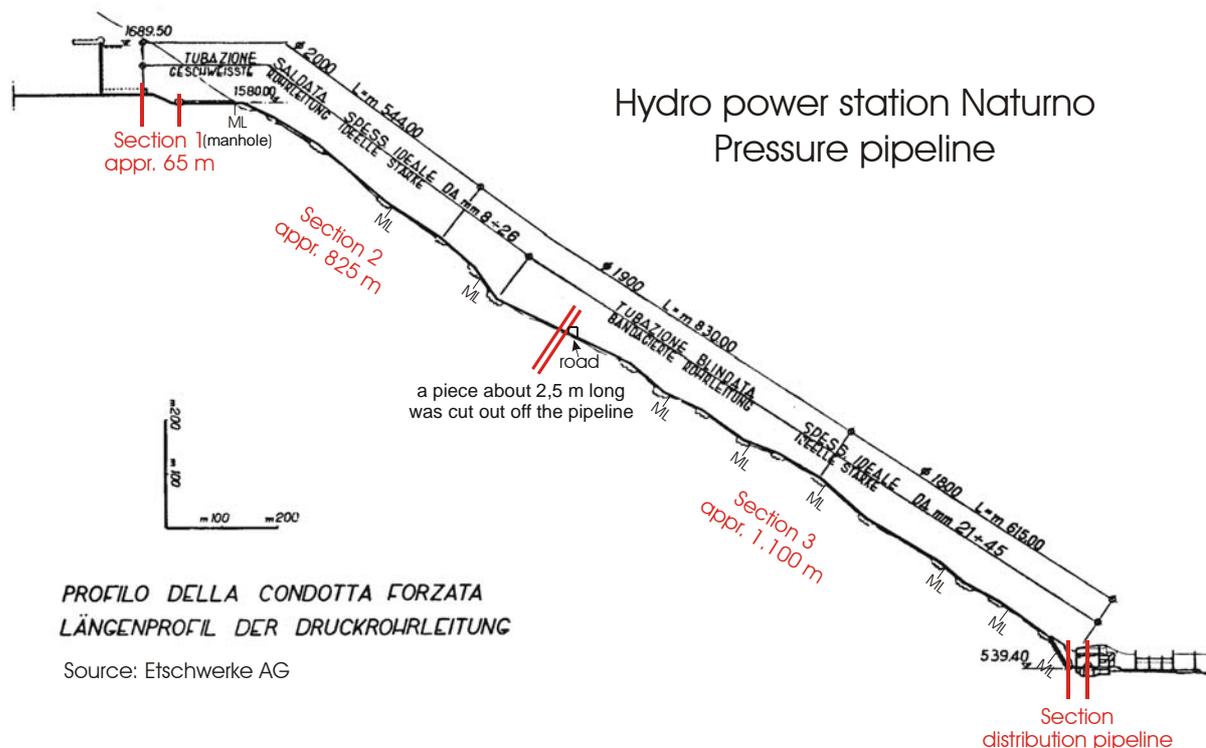
The following sketch gives a survey of the installation of the site and the actual division of the working sections.

As the pipeline is 2000 m long and had to be completely treated within 90 days, it was divided just above the middle. The only road on the mountain side crosses the pipeline at about 1.100 m, measured from the bottom side. At this spot, a piece about 2,5 m long was cut out off the pipeline, so two completely separate sections, with separate acclimatisation and separate means for entering the pipeline for both halves.

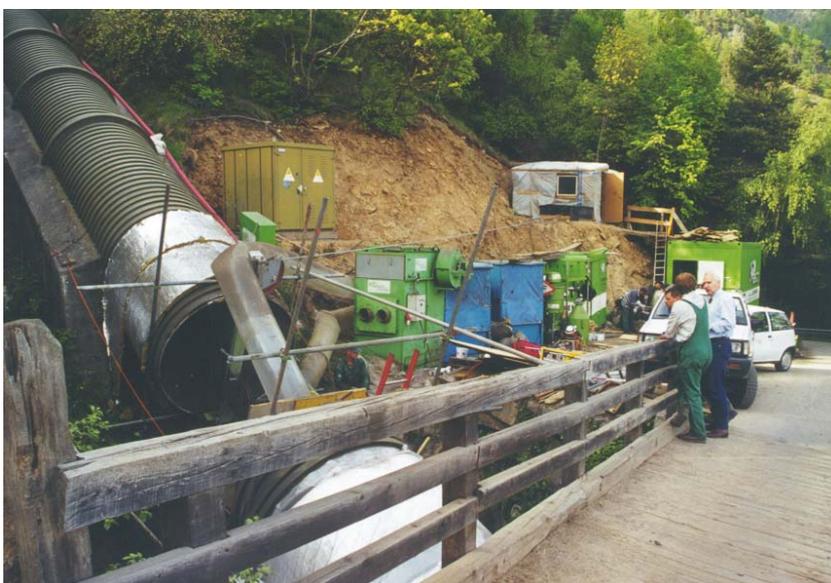
The picture on the left, which was taken after completion of both section 2 and 3, shows the installation of the site at the station in the middle without housing. In the background, you can see the winch chamber. The pulley block is fixed on the lower part of the upper pipe.

After the coating on the slope was finished and the installation for moving through the pipe was disassembled, the piece of the pipe that had been cut out was put back, welded, tested and coated with Humidur®.
